**COMMENTS AND OBSERVATIONS
ON THE DRILLING ACTIVITIES PERFORMED BY
EPA's TAT CONTRACTOR
AND SUBCONTRACTED DRILLER
DURING THE PERIOD OF
JUNE 23 THROUGH JUNE 27, 1992**

**UNITED PARK CITY MINES COMPANY
309 KEARNS BUILDING
SALT LAKE CITY, UTAH 84101**

**PIONEER TECHNICAL SERVICES, INC.
P. O. BOX 3445
BUTTE, MONTANA 59702**

JULY 13, 1992

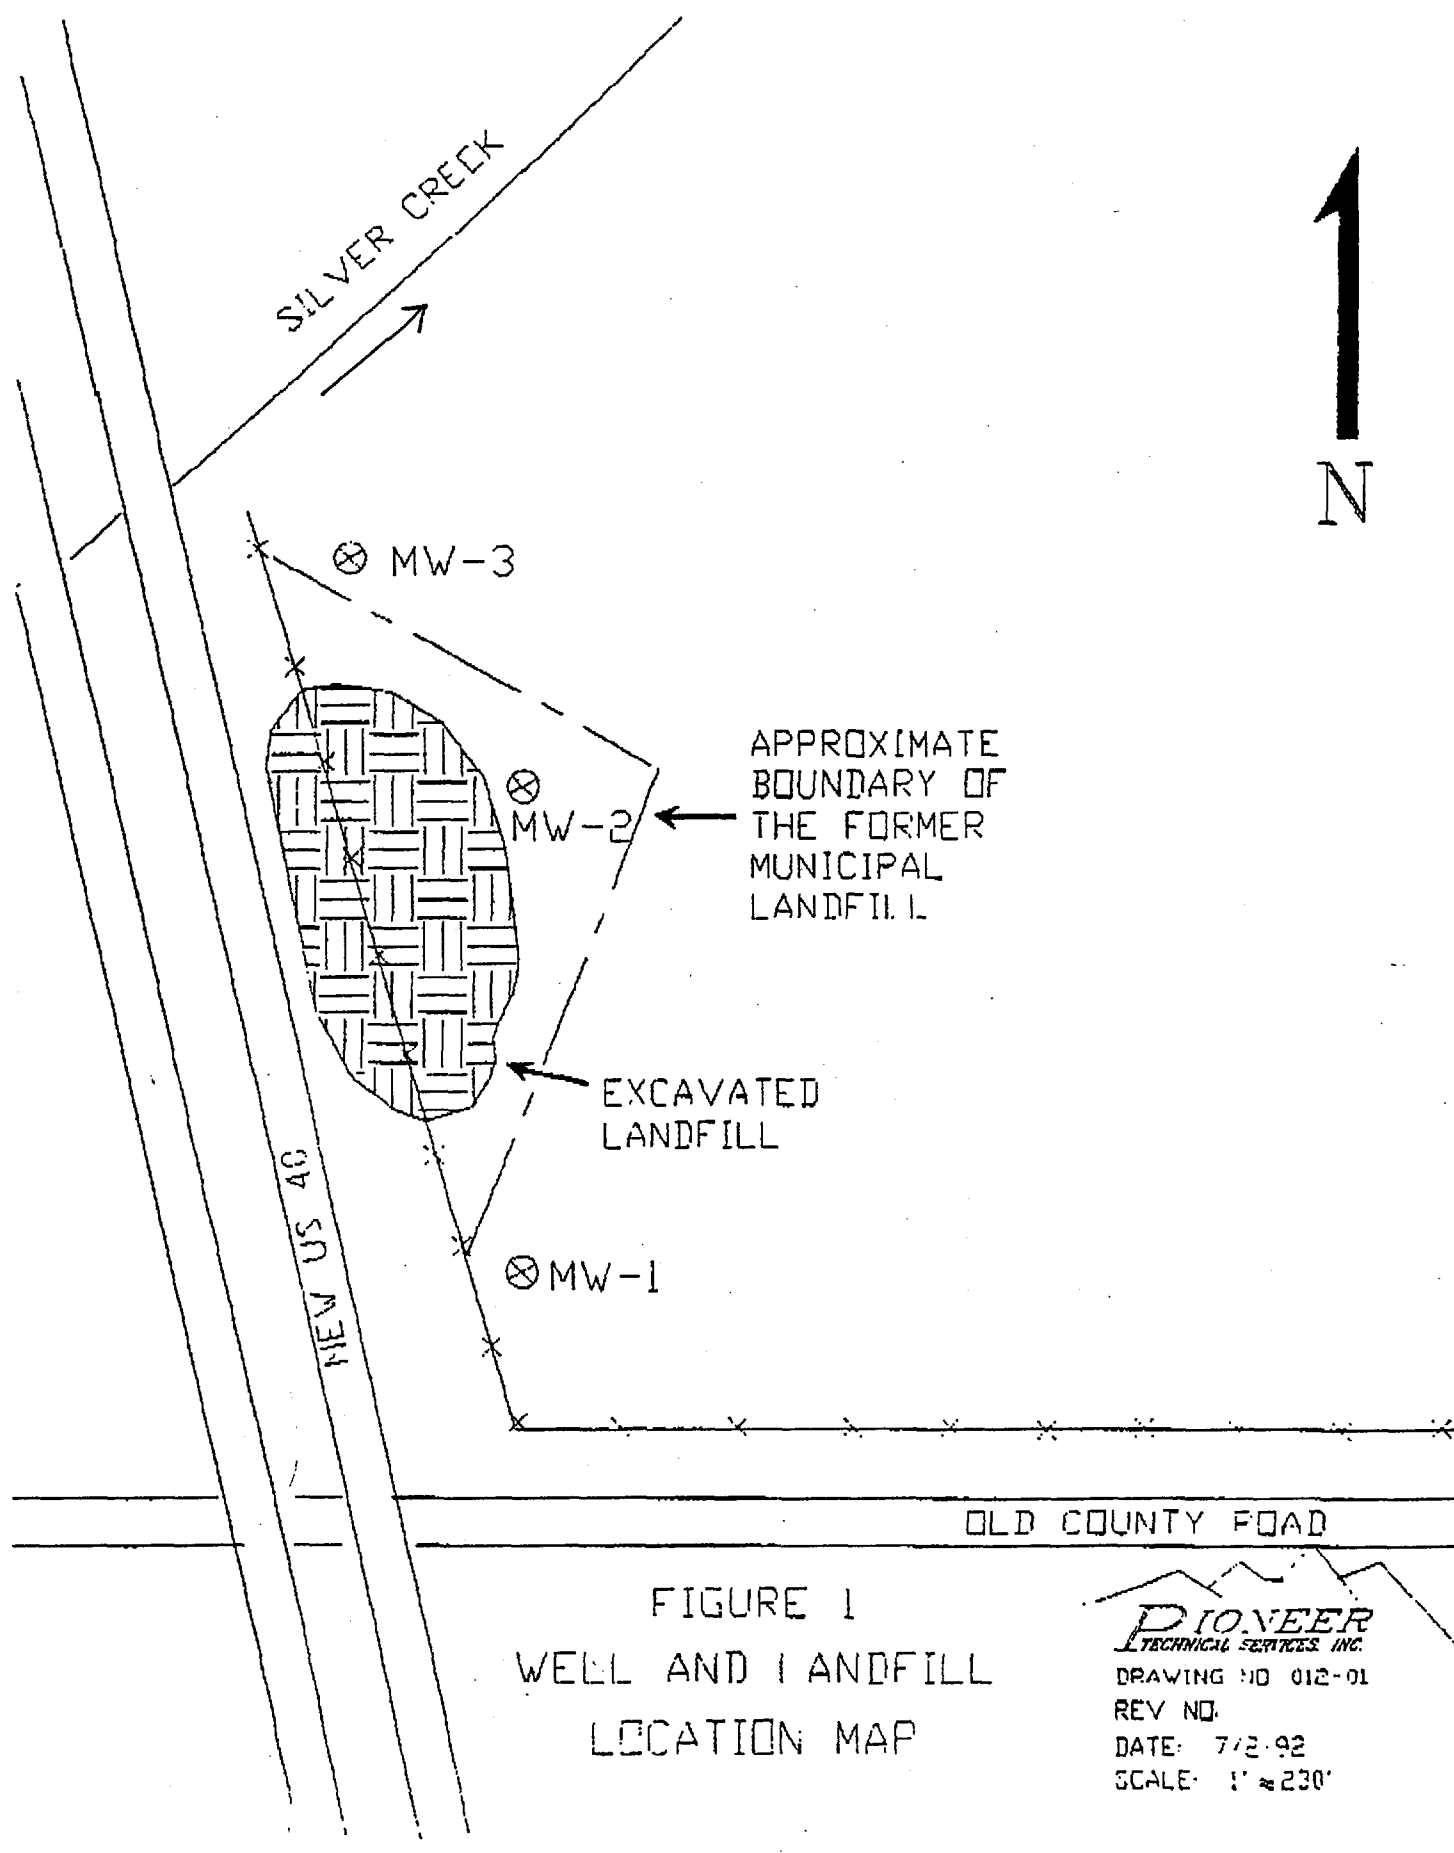
FIGURE 1
WELL AND LANDFILL
LOCATION MAP

A) MONITORING WELL MW-2 WAS INSTALLED WITHIN THE BOUNDARY OF
THE HISTORIC PARK CITY LANDFILL, CONTRARY TO USEPA GUIDANCE.

The most blatant violation of EPA guidance in the drilling of these monitoring wells was the placement of well MW-2 within the boundary of the historic landfill (see Figure 1). USEPA direction is clear - drilling directly through municipal landfills is to be avoided in order to protect underlying groundwater, and for obvious safety considerations; rather, drilling is to be conducted off of the actual landfill and downgradient from it. Prior to drilling, the TAT was advised by the property owner (UPCM) that the location selected for MW-2 was within the former landfill boundary. For whatever reasons, the TAT declined to relocate the well 100 feet to the north, out of the former landfill. After drilling five to ten feet, drill cuttings and split-spoon sample cores showed that the borehole was obviously within the landfill. ?

At this point, the proper procedure would have been to properly abandon the borehole, move off the landfill, and drill a new borehole in a safer location; however, the TAT persisted with drilling in the landfill. If TAT had adequate training and experience in hydrogeology, they would have anticipated the potential for problems arising from drilling through a landfill, and chosen to drill elsewhere. TAT's lack of experience and refusal to follow USEPA policy resulted in one of the most serious monitoring well installation calamities possible (described below). ?

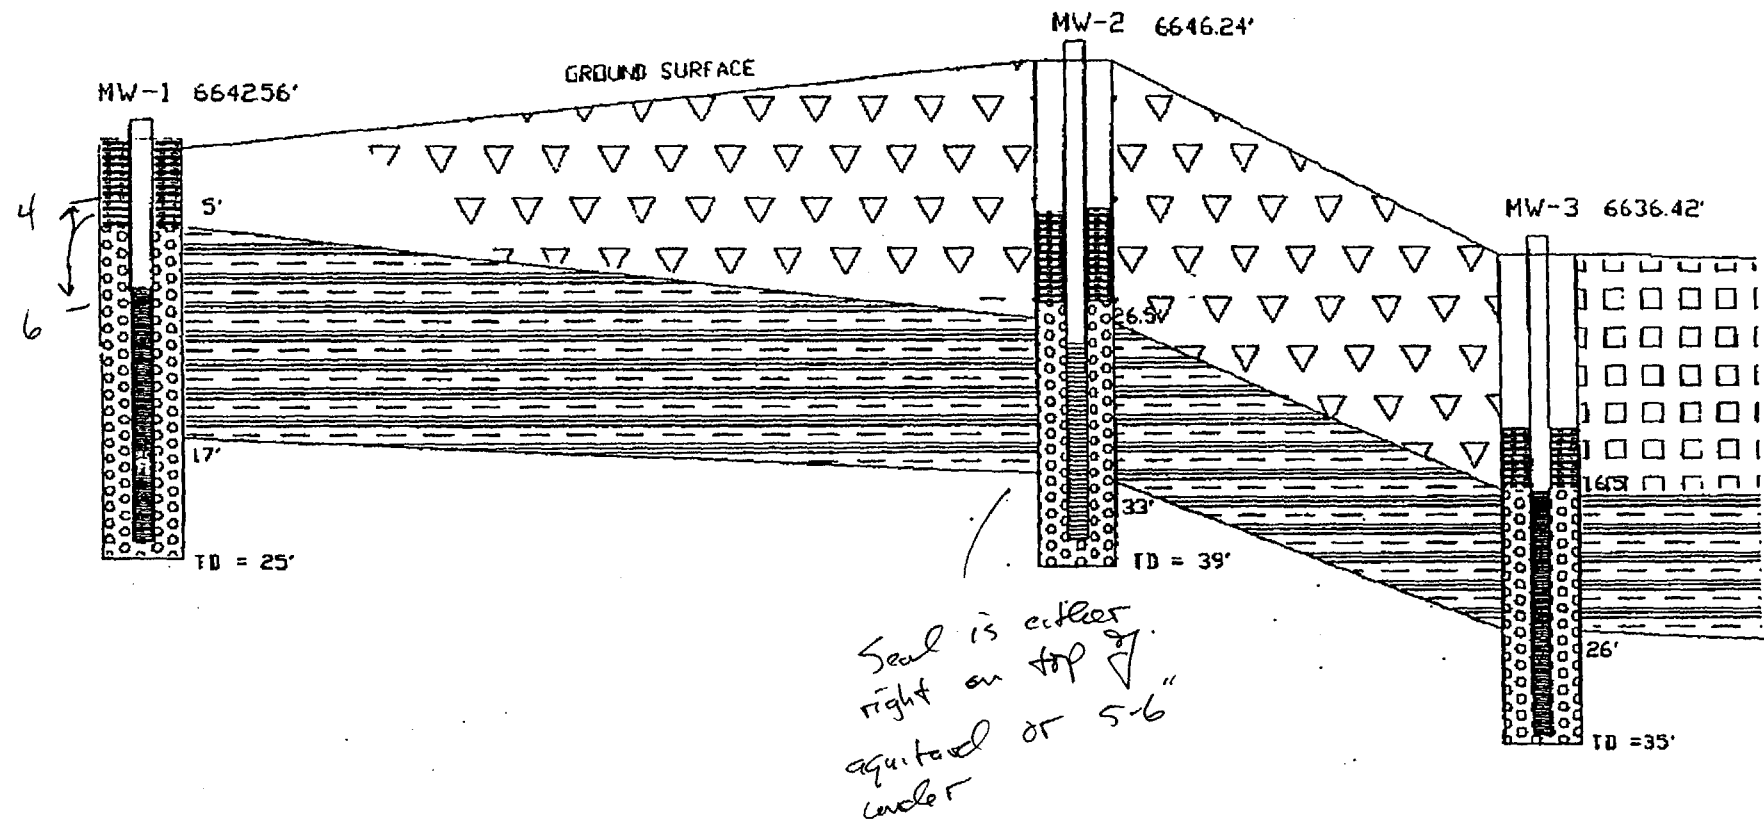
FIGURE 2
GEOLOGIC CROSS SECTION
AND LANDFILL MONITORING WELLS

This is the most egregious violation of sound hydrogeologic practice and may have violated State of Utah regulations for monitoring wells, water wells, or groundwater protection. The drilling of all three monitoring wells showed that the underlying groundwater was a confined or semi-confined aquifer system. In each borehole, the saturated zones were found beneath a thick, apparently continuous aquitard that isolated the landfill materials from underlying groundwater system (see cross-section, Figure 2). In each of the three monitoring wells, the static water level rose to an elevation significantly higher than the level at which water was first encountered. ?

Borehole MW-1 (upgradient) first encountered this aquitard at 5 feet below ground surface (bgs) and the first groundwater at 16 to 18 feet below the surface (the base of the aquitard). The

borehole was deepened to 25 ft bgs and the well was completed; however, rather than installing 10 feet of screen to 15 ft bgs (near the first water), TAT put in 15 feet of screen, possibly interconnecting several discrete saturated zones. The following day, the water level had risen to only 8 feet bgs, clearly indicating that the underlying groundwater was under pressure.

After ill-advisedly locating well MW-2 within the former landfill (discussed above), drilling commenced. For whatever reason, the TAT did not closely monitor the drill cuttings from the borehole; however, UPCM's hydrogeologist was because of the geology observed at MW-1 and concern about breaching the aquitard underlying the landfill. At 25 ft bgs, a two-foot split spoon core revealed six inches of the aquitard (a reddish-brown clay) in the bottom of the core barrel, clearly showing the top of the aquitard to be at 26.5 ft bgs. The TAT erroneously recorded the top of this unit at 25 ft bgs. Drilling continued (slowly) and water was encountered between 34 and 35 ft bgs. The drilling was halted at 39 ft bgs and well completion activities began.

At this point, serious errors in judgment and perhaps criminal negligence, caused the completion of well MW-2 to be entirely inappropriate, if not illegal. First, 10 feet of screen were placed in the well, bringing the screened section up to 27.5 ft bgs, very close to the top of the aquitard unit. Then, the filter pack was brought up to 26 ft bgs, above the aquitard. The bentonite seal placed on top of the sand was intended to plug the aquitard; however, due to careless geologic logging, it completely missed the aquitard and provides no such seal. The formerly continuous barrier between the landfill materials and groundwater has been breached by the drilling and not repaired during well construction. Water level measurements on subsequent days show clearly that the underlying water is under pressure and has risen up the borehole to exactly 26.5 ft bgs, the top of the aquitard. The underlying groundwater is now flowing up the well under pressure, out through the filter pack along the top of the clay aquitard and into the base of the formerly dry landfill. When this water discharges from the base of the landfill, either as springs or to Silver Creek, it will be contaminated by whatever is in the landfill.

Prior to the installation of well MW-2, the landfill was isolated from the groundwater system. EPA and their TAT contractor have breached this natural compacted clay barrier and are thus solely responsible for the ensuing potential groundwater and surface water contamination.

The third well, MW-3, was moved further north at the urging of UPCM. During drilling, construction debris was encountered, but no municipal landfill wastes. This well encountered the same hydrogeology and was similarly misconstructured; however, the results are not as critical. The same aquitard (reddish-brown clay) was encountered in MW-3 at 16.5 ft through 26 ft bgs and water was again encountered beneath it. Instead of completing the well with the screened section at 26 to 34 ft bgs, TAT decided to place 15 feet of screen in this well, 5 feet into the aquitard. Filter pack was again placed in the borehole up to the top of the aquitard (16.5 ft bgs), and the bentonite seal above that, again missing the aquitard and not sealing the borehole. The result of this is again, the upward migration of formerly confined groundwater into the construction debris and eventually out of the filled area to surface water.

Most states require that when drilling into or through confined groundwater systems that every precaution be taken to avoid interconnection of the confined zone with other water bearing zones. EPA's contractor was clearly negligent in this regard; the confined zone is now connected to the surficial system, including local surface water, and will continue to push water into the landfill until either the well is properly abandoned or the hydrostatic pressure is equalized.

- secondly, careful geologic logging would have shown the aquitard unit to be between 26.5 and 33 feet bgs, and hence, no need to screen above 33 ft bgs; and,
- finally, the placement of screen and sand up to the base of the aquitard (33-38 ft bgs) and bentonite within the aquitard (26-33 ft bgs) could have maintained the integrity of the natural barrier between the landfill materials and the underlying groundwater system.

In any event, the serious nature of the well construction disaster described above is at least unprofessional and at worst illegal. I recommend that all of these wells be properly abandoned as soon as possible. It is especially critical that MW-2 be plugged so that it does not continue to flood the landfill.
